FAULT ANALYSIS OF GEARBOXES IN OPEN PIT MINE

The research was carried out on 95 gearboxes that were collected throughout 2017, during general repairs at Drmno mine workshop.

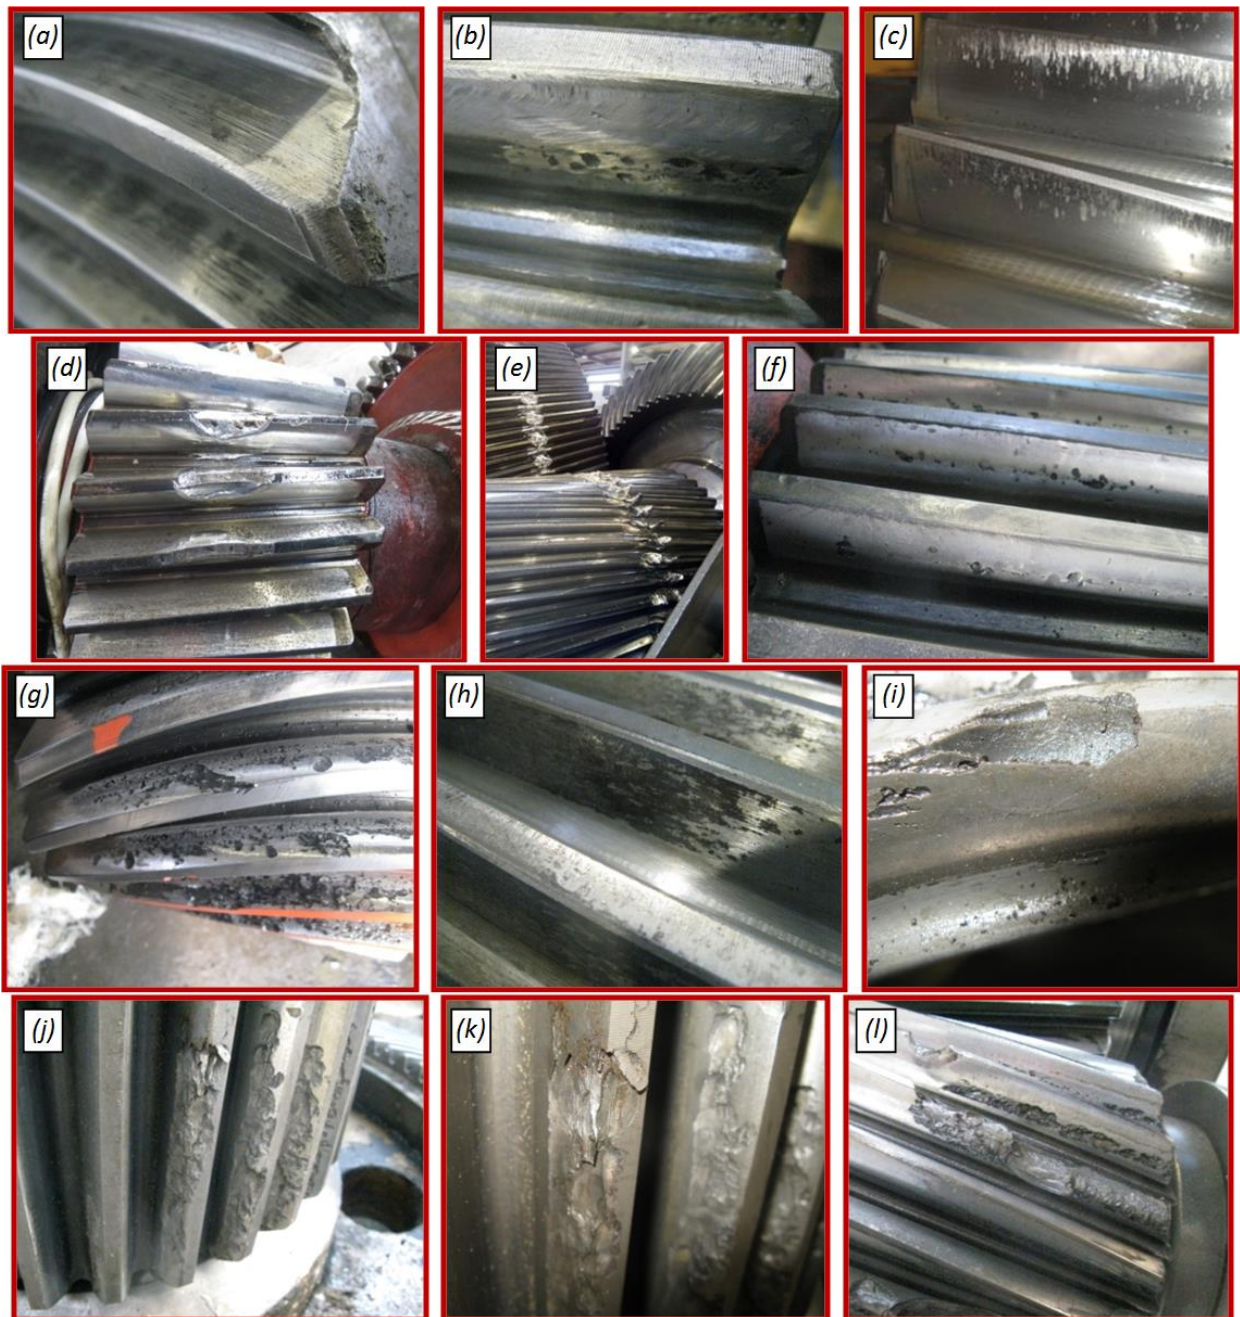
Fig.1. Typical gear failures on analyzed gearboxes

Scuffing occurs on the working surfaces of tooth flanks, most often between the tip and root circle [10]. It is formed as a result of oil film disruption, local metal contact, sudden temperature increase due to friction, local welding and tearing of welded particles [10-13]. It is manifested by the appearance of creases and notches in the sliding direction. An example of pronounced scuffing due to a large deviation in the parallelism of coupled gears axes is given in Fig.1.c.

Permanent deformations occur on the tip, side, and very often on the entire tooth. They are formed as a result of high loading, impact due to the large side clearance, interruption of lubrication which leads to warming and reduction of gear material strength, as well as when foreign particles pass through coupling [10-12]. They are manifested by the appearance of dents, creases or complete reshaping of tooth parts. Examples of permanent deformations due to the presence of chipped parts of other elements in the coupling are given in Fig.1.d and 1.e.

impact on service life, according to ISO 10825 [9], fatigue wear is classified into: initial pitting, progressive pitting (Fig.1.g), micro pitting (Fig.1.h), flake pitting (Fig.1.i), spalling (Fig.1.j) and case crushing.

Fatigue cracks (Fig.1.k) result from cyclic loads the intensities of which are most likely lower than the material tensile strength.

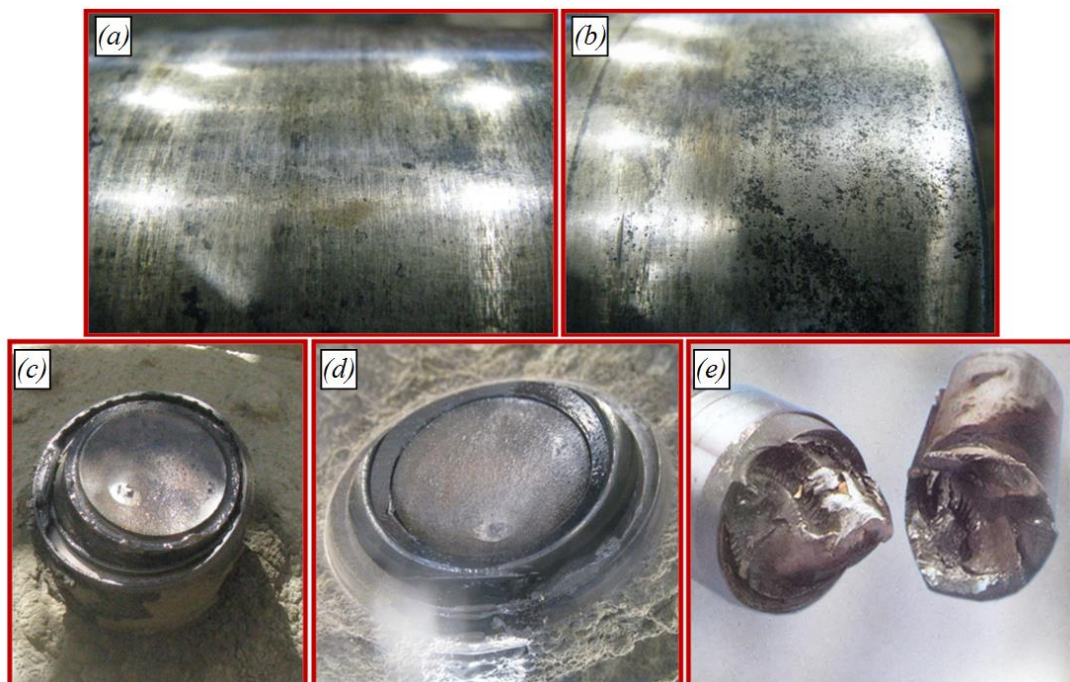
Fig.2. Typical shaft failures on the analyzed gearboxes

Surface deteriorations, shown in Fig.2.a, occur at locations of relative displacement of firmly mounted parts such as bearings, gears, and couplings. They are manifested by the appearance of dark brown spots that represent fretting corrosion (Fig.2.a), as well as by the emergence of clefts in the rotating direction (Fig.2.a) which represents abrasive wear.

Surface fatigue phenomena occur on the stacked parts. They are caused by the relative displacement of elements along the shaft in cycles n times. They are manifested by the appearance of smaller or larger holes, forming a characteristic relief in phases (Fig.2b), as in gears.

Shaft failures most often occur on the input shafts of the worm and bevel gears, which are made as a one piece with the shaft, at places of pronounced discontinuities in cross section sizes. They occur as a result of overloading, plastics deformations or fatigue, and each type of fracture is manifested by the characteristic appearance of the fracture surface [16]. In case of overload, the fracture surface is relatively rough. In case of shaft fatigue fracture, the fracture surface is relatively smooth, and the final fracture is relatively rough. An example of such a fracture is shown in Fig.2.c, and 2.d, where a characteristic rough portion representing the final fracture can be observed, while the rest of the fracture surface is smooth. Bending stress fractures are perpendicular to the shaft axis, just as in Fig.2.c and 2.d, while torsional stress fractures are often set at an angle of 45° to the shaft axis of the, just as in Fig.2.e.

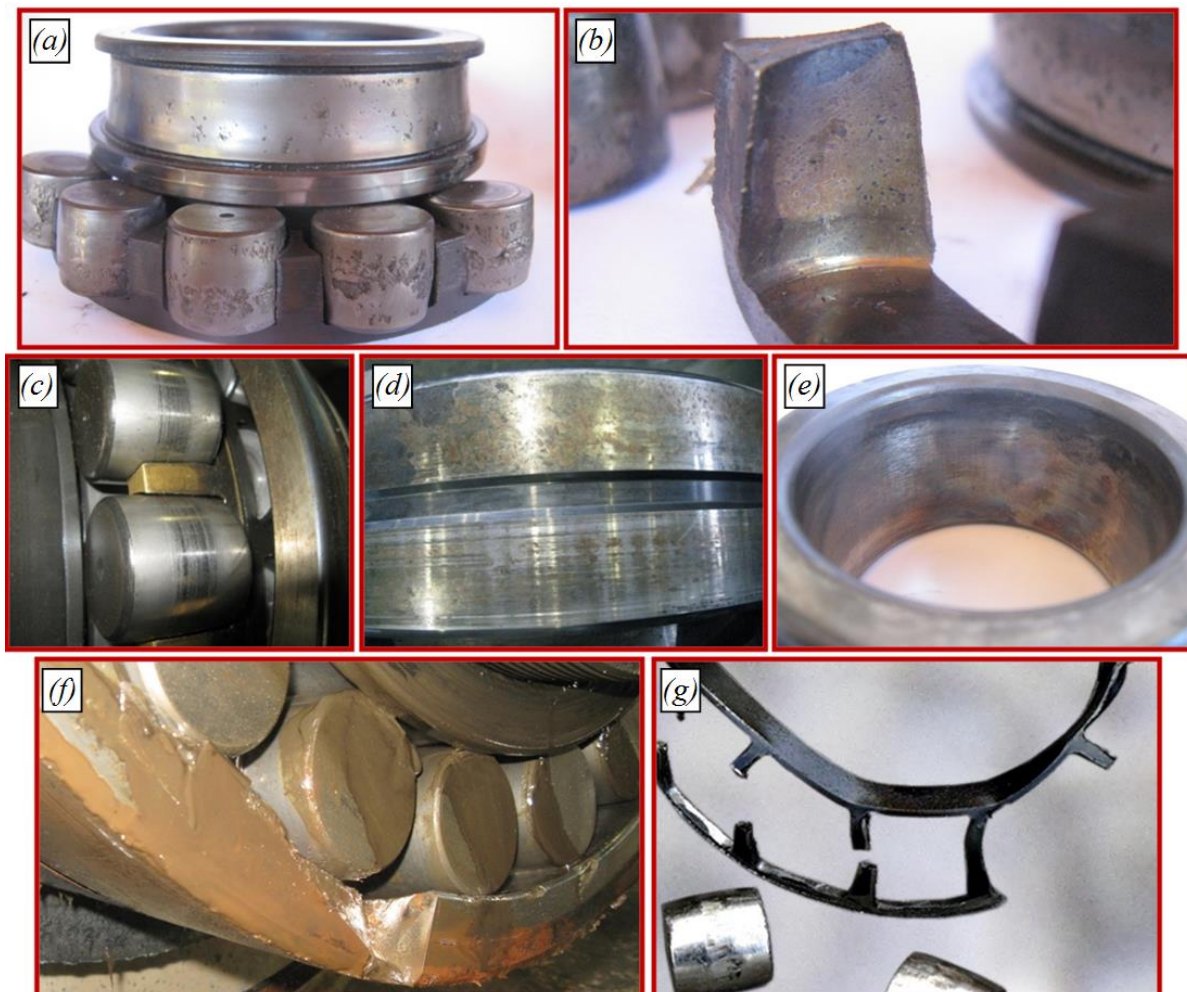
Fig.3. Typical bearing damages on the analyzed gearboxes

Fatigue (pitting) is the result of cyclic stress that develops at the contact surface [11]. It is manifested by the appearance of pits in the initial phase and the destruction of the contact surface in the final phase [19-21], creating a characteristic relief, as in gears and shafts. An example of pitting on a double-row roller bearing is shown in Fig.3.a, while Fig.3.b shows an example of pitting on a bronze cage of a roller bearing.

cavitation of the lubrication inlet pipelines [21]. They are manifested by damaging the contact surfaces in the form of notches (Fig.3.c), grooves and scratches.

Oxidation corrosion is caused by the presence of moisture. It is manifested by the appearance of oxide coatings of different thicknesses and colors: thin - relatively light ($<40\ \mu\text{m}$), medium - light brown and gray ($<500\ \mu\text{m}$), as well as thick - usually dark coatings ($>500\ \mu\text{m}$) [11]. As the thickness of the oxidized coatings increases, they burst and are removed from the surface, leaving a relief surface. An example of oxidation corrosion on the outer bearing ring is shown in Fig.3.d.

Fretting corrosion occurs when there is a gap between the shaft and the inner ring or housing and the outer ring [19-21]. The gap allows for the relative displacements of the aforementioned parts resulting in chipping of small particles of material. It is manifested by red oxide coatings or black coatings in the presence of oil or borax peroxide (rust) coatings in the presence of moisture [11]. An example of fretting corrosion on the inner bearing ring is shown in Fig.3.e.

fatigue [19-21]. They are manifested by the loss of material from the damaged element surface. Overload fracture is usually caused by rough handling (impact) when the bearing is mounted or dismantled (Fig.3.f), by use of inadequate tools during mounting, or when the bearing is hammered onto an incorrect shaft diameter. Fatigue fracture occurs at sites where surfaces have already been affected by pitting. In this case, cracks continue to grow until complete fusion and final fracture of the element. An example of cage material fatigue fracture is shown in Fig.3.g.

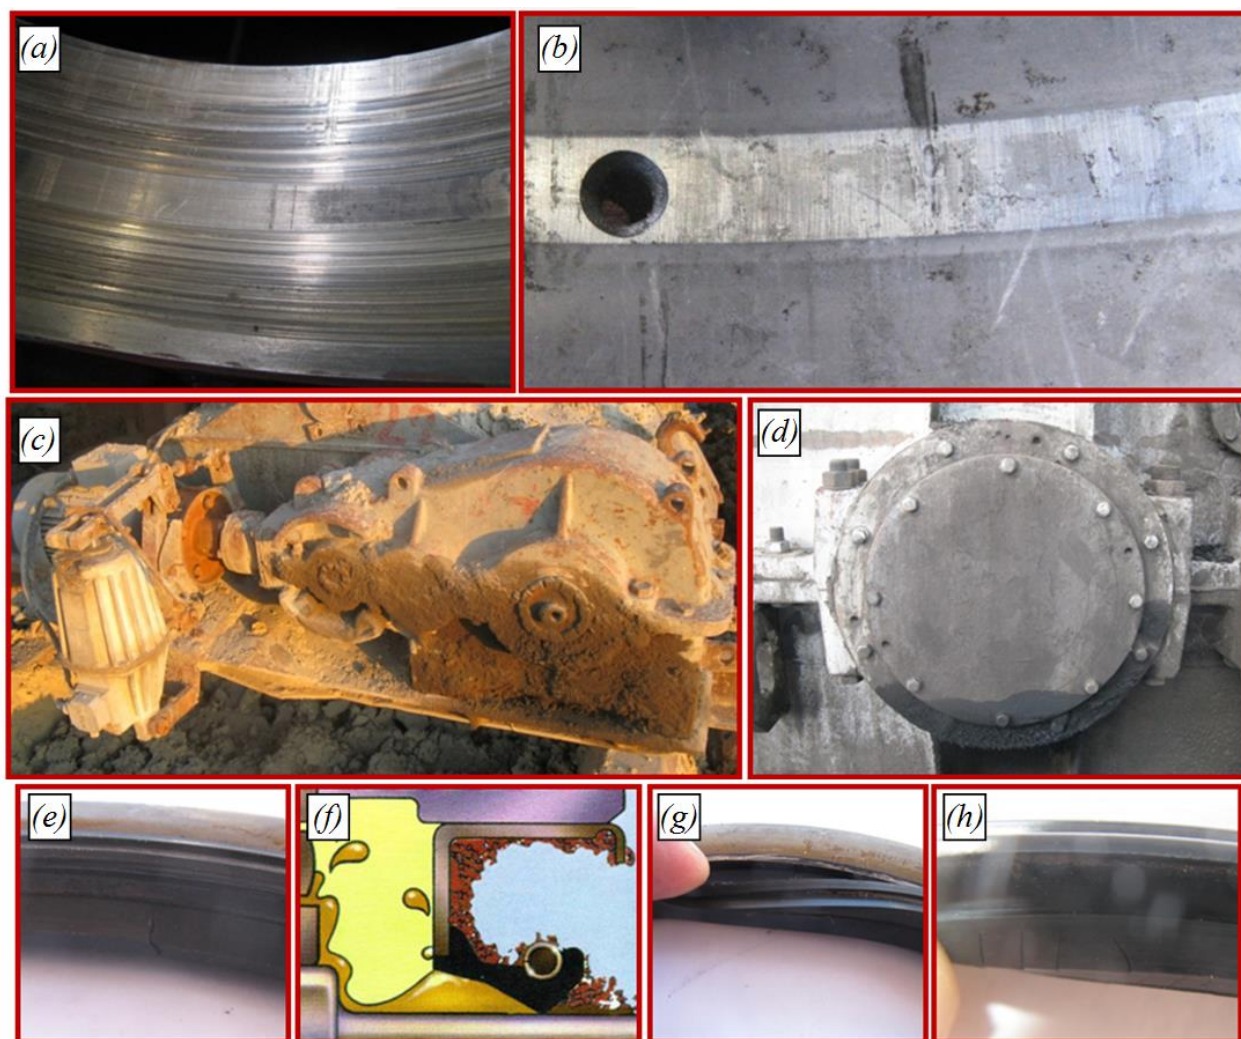
Fig.4. Typical housing failures on the analyzed gearboxes

Oxidation corrosion is caused by the presence of moisture, and almost all housings are exposed to atmospheric precipitation. It is manifested by the appearance of oxide coatings of various thicknesses and colors, as in bearings. An example of a partially oxidized housing is shown in Fig.4.c. First, the oxidized layer is formed at the places of damaged surface protection, such as edges of a smaller radius, or surfaces damaged during mounting/dismantling, and then the oxidized layer tends to spread, with layer thickness depending on the material characteristics, surface protection, temperature and the amount of moisture.

Sealing failure occurs on the cuff seals, the thin layer of sealant between the housing and cover, and due to insufficient tightening of cover screws [16]. They are manifested in many ways. Fig.4.d shows an example of oil leak due to the sealant failure on the side cover. Fig.4.e shows an example of notched rubber lining when mounted on a shaft with a wedge groove. Also, during mounting, the spring that presses the rubber lining may be damaged or may come out of its groove. Sometimes it is improperly set as shown in Fig.4.f. Excessive exposure to high temperatures causes rubber to harden and crack, as shown in Fig.4.g. Also, during exploitation, the rubber liner can separate from the tin L profile (Fig.4.h), which also causes oil to leak.

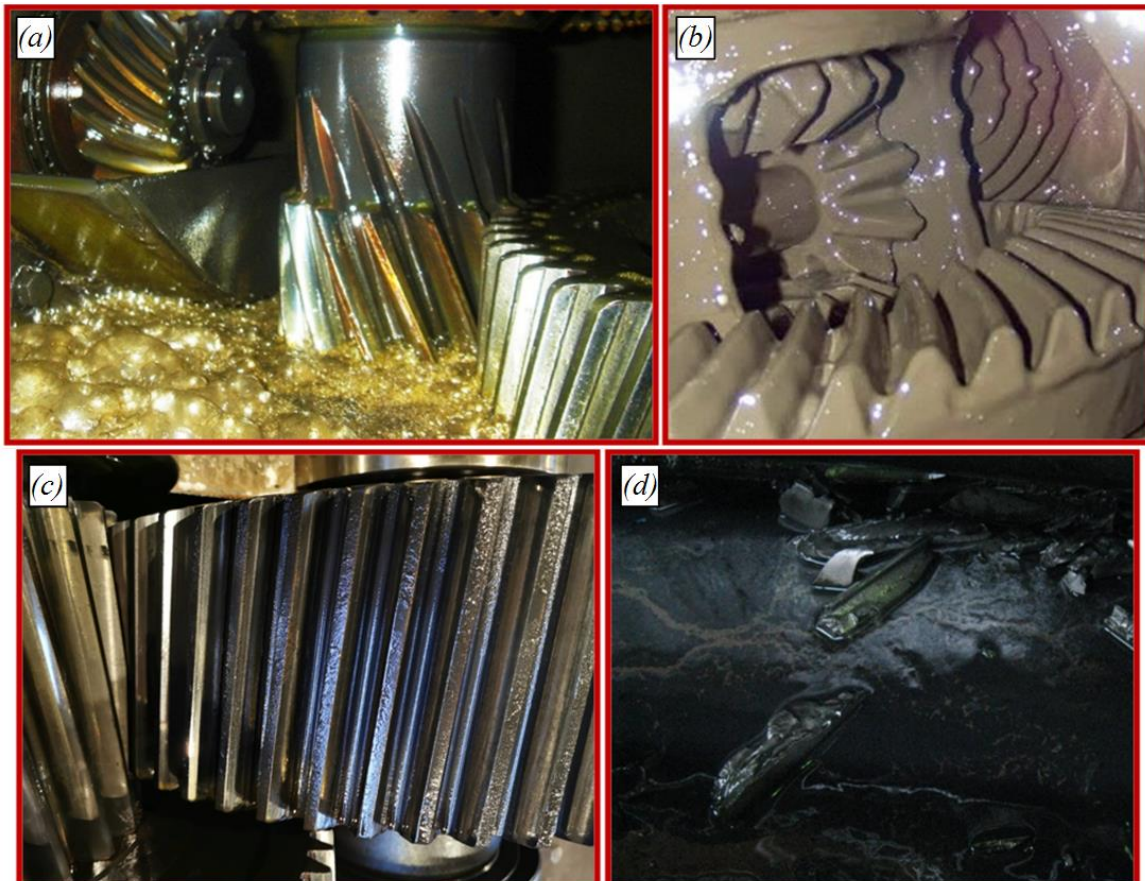
Fig.5. Typical lubricant problems

Oil foaming occurs due to the application of inadequate viscosity oil, due to the low or too high oil level, air penetration, mixing oil with another oil of different viscosity, oil contamination with dust and water [23]. It is manifested by the appearance of small air bubbles on the lubricant surface. Formed foam impedes oil temperature maintenance, accelerates oxidation processes and stimulates aeration, which results in intense cavitation, poor lubrication, and reduced service life of the oil itself. An example of oil foaming in a cylindrical bevel gearbox is shown in Fig.5.a.

An example of chipped teeth in oil is shown in Fig.5.d.

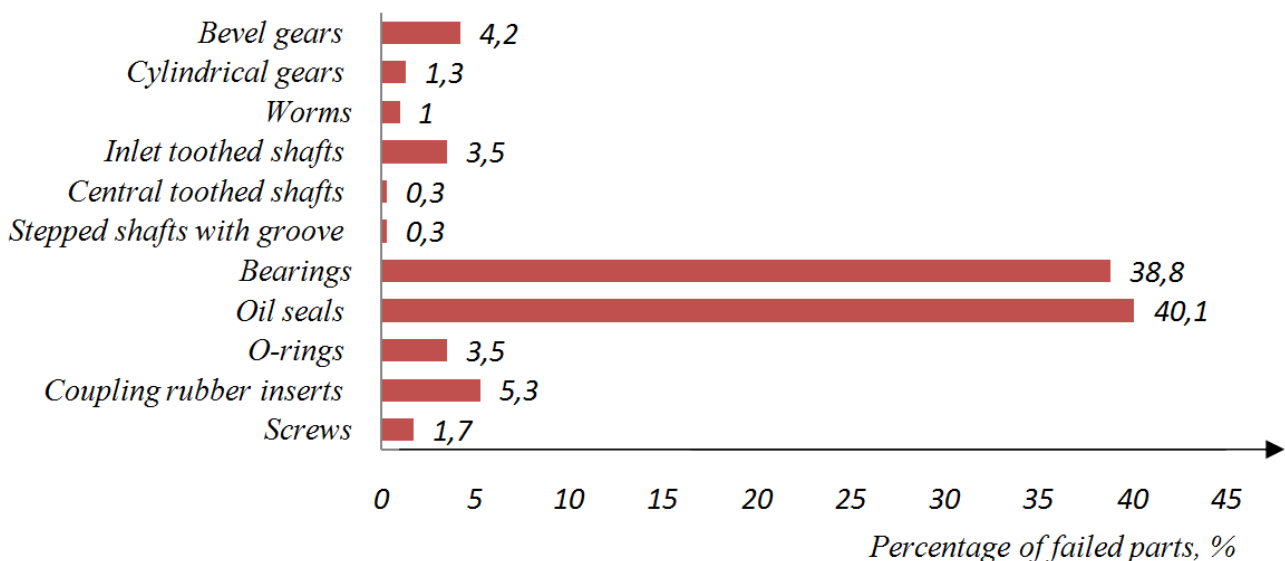
Fig.6. Percentage of occurrence of various types of failures on the tested gearboxes

show that failures are the most likely to occur on oil seals (40.1%), whether cuff seals or a thin layer of sealant, as well as on bearings (38.8%), Fig.6. If oil leakage is minimal or does not require greater amounts for topping, the gearbox will operate under such conditions until the failure of another element that would require total shutdown. As a result of incomplete sealing, water, dust, and other undesirable particles penetrate the inside of the gearbox.

In addition to bearings, a number of failures occurred on gears: bevel (4.2%), cylindrical (1.3%) and worm (1%), as well as on shafts: inlet toothed (3.5%), central toothed (0.3%) and stepped with groove (0.3%), Fig.6. Almost all of these gears, except one cylindrical, failed at the inlet of the gearbox, as expected. The highest rpm is at the inlet, usually 1000, 1500 min^{-1} . There are the highest temperatures and the greatest shocks at startup as well. Gear failures are most commonly manifested by pitting, spalling, tooth fractures and permanent deformations. All this results in an increase in vibration and noise.

The third group of elements consists of failures of coupling rubber inserts (5.3%), screws (1.7%) mounted on covers, Fig.6. The consequences of failure of these elements are far less.

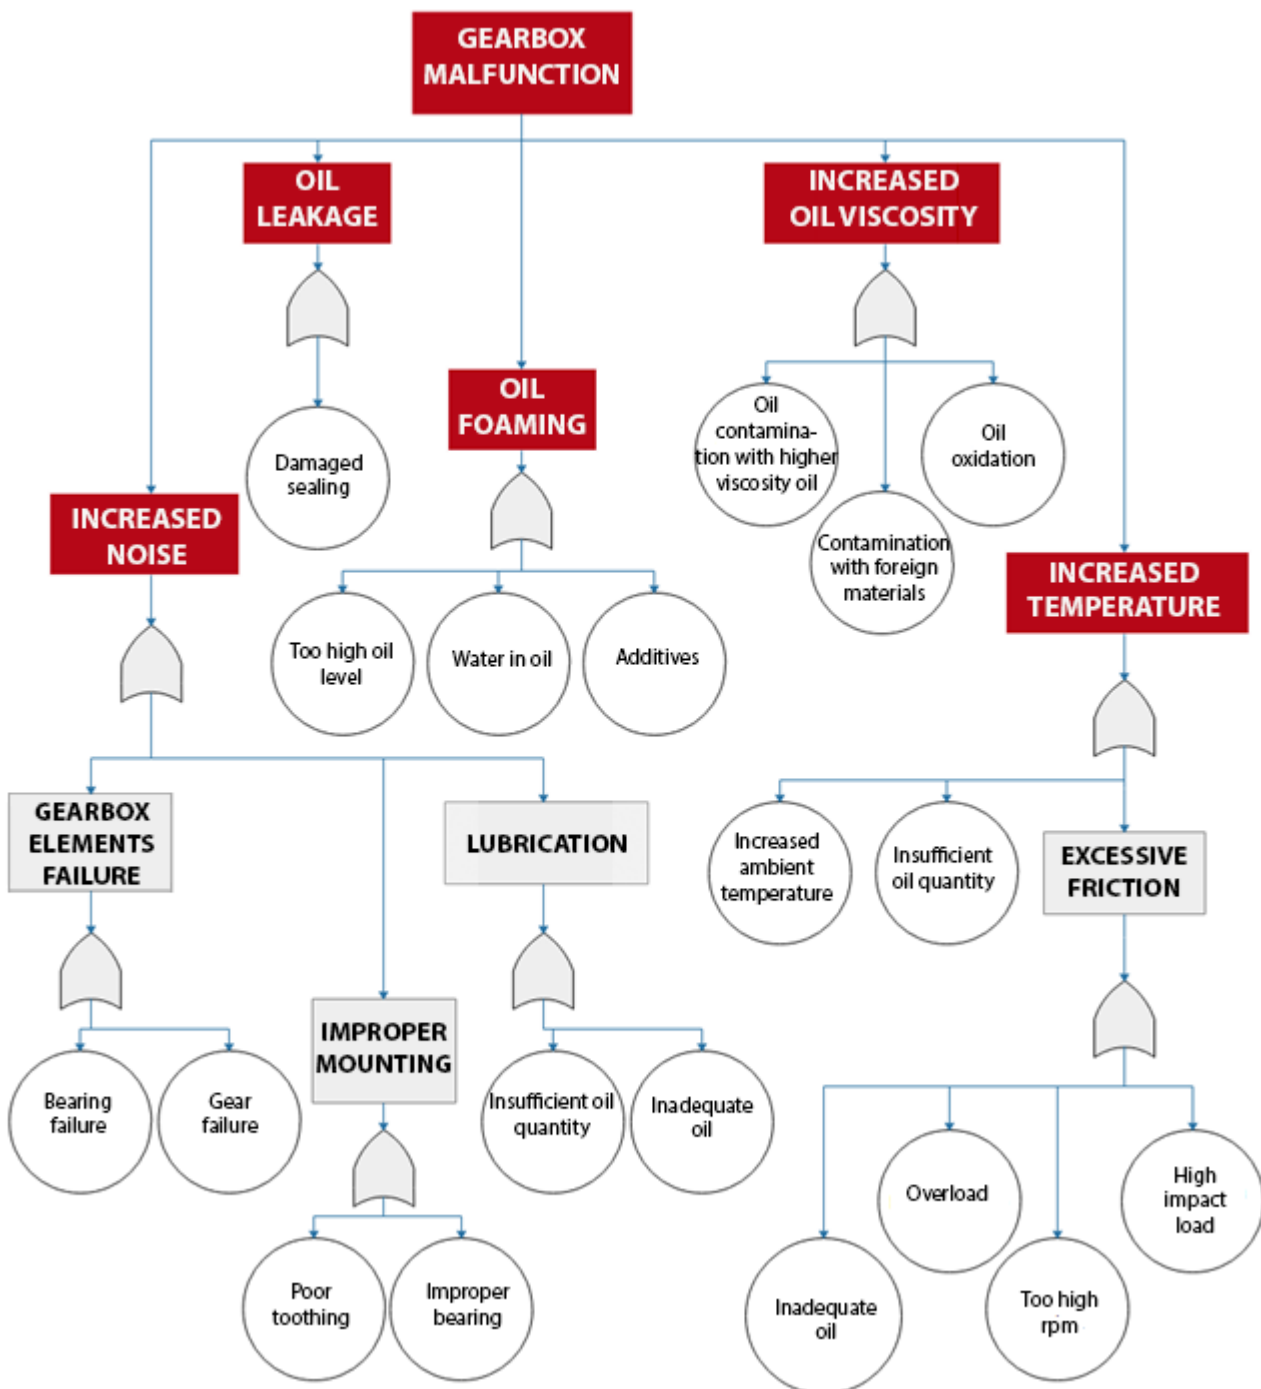
Fig.7. Fault tree of analyzed gearboxes

One of the most suitable methods for analyzing the most likely causes of gearbox failure is the Fault Tree Analysis, which is shown in Fig.7. The unwanted, top event, defined as "gearbox malfunction" may be complete or partial. If the gearbox loses its function, the malfunction is complete. On the other hand, if the gearbox works but its performance is significantly impaired, then the malfunction is partial.

The causes of noise increase are usually related to gearbox element failure, primarily bearings and gears, or to lubrication with regard to insufficient amount of oil, application of inadequate oil, or oil of insufficient viscosity. However, noise does not have to be due solely to exploitation conditions. The cause may also be a faulty mounting in the form of poor toothing or mounting bearing with a larger clearance than permitted.

The cause of oil leakage is usually damaged sealing. Possible types of seal failures are given in Chapter 2.4.

The cause of oil foaming is high oil level. In such a situation, oil is swirled and air enters the oil. Also, water, as well as some types of additives, in oil can cause foaming at elevated temperatures.

Causes of oil viscosity increase include contamination of oil with higher viscosity oil, oxidation of oil due to high-temperature operation, and contamination with foreign materials, e.g. water, dust, wear products.

The causes of gearbox temperature rise are generally related to insufficient oil content. Also, rising temperatures may be due to increased friction. The causes of increased friction are inadequate oil, overloads, excessive rpm, and high impact loads.
